Manhole Inspection Summary

Manhole # S41GG_028MH

Insp Date: **3/19/08 10:47 AM**

Location Address: **1403 PRESTON ST**

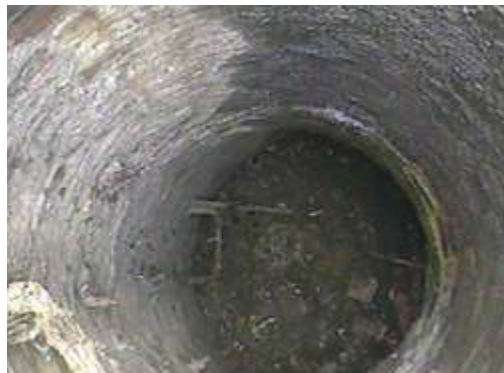
Top View

Condition: ☐ Sound ☒ **Cracked** ☐ Root Intrusion ☐ Loose Brick ☐ Deteriorated

Count: **1** Missing: **3** ☒ **Corroded**

cracked chimney and corroded steps
